## Structural Condition Assessment

*CSG Project Number:* 125026

*Subject:* **Sedona Cultural Park  
Sedona, AZ**

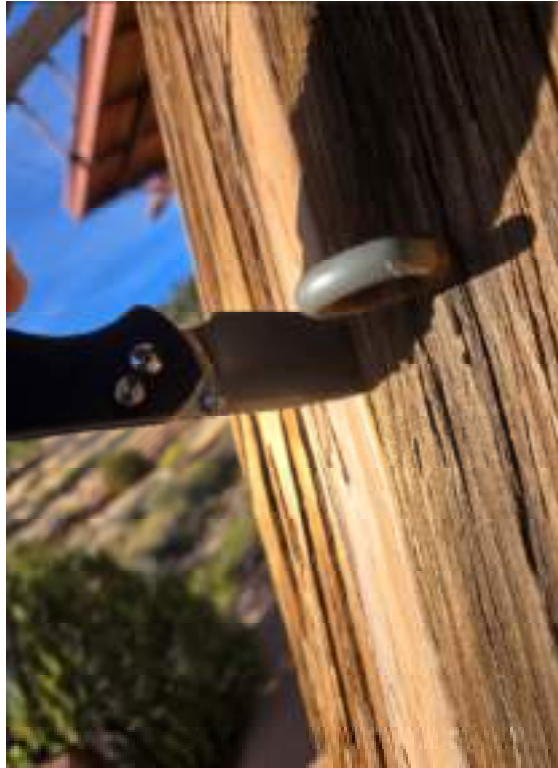
Significant deterioration and weathering were observed on the top two laminations of the glulam beams (Figure 2A). Additional weathering was observed on the perimeter of the glulam beams (Figure 2B). Some of the connections have missing bolts (Figures 2C and 2D).

*Figure 2A: View of the dry rot at east end of north beam (knife is embedded approximately 2")*

Structural Issue #2: The weathering of the beams has affected their structural capacity. The top two laminations of each of the glulam beams are almost completely compromised.

Due to the deterioration of the glulam beams, they will require structural remediation to restore the structural capacity lost to weathering. The deterioration noted does not appear to be extensive enough to require full replacement of the members, nor does it render them useless for re-purposing for a new structure. Further evaluation of the glulam beams is necessary before a determination can be made on the costs associated with remediation or suitability for re-purposing and compared to the costs of a new glulam.

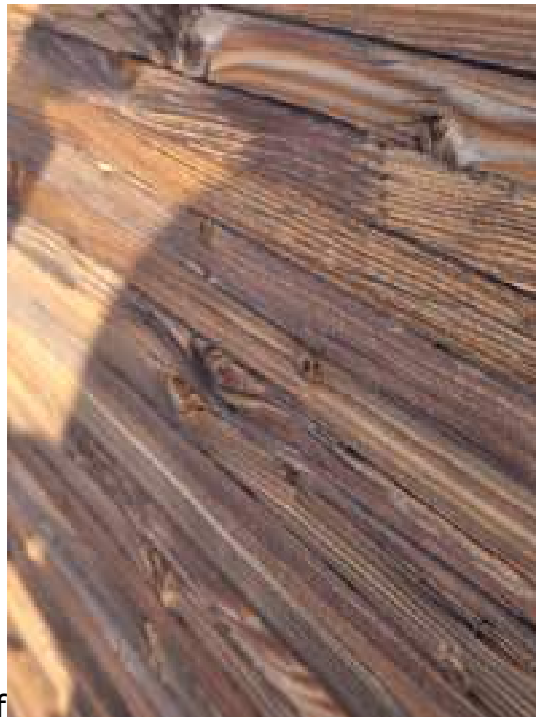
*Figure 2B: View of typical weathering of glulam beams*

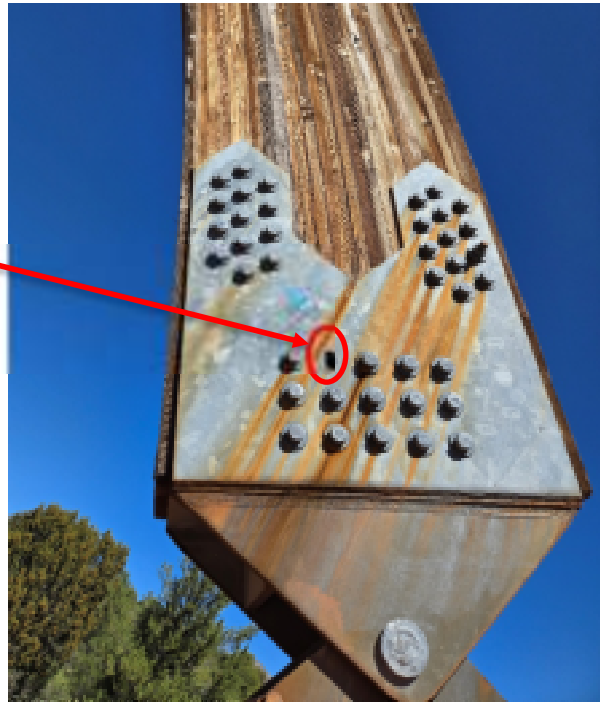
*Figure 2C: View of missing bolt in base connection*

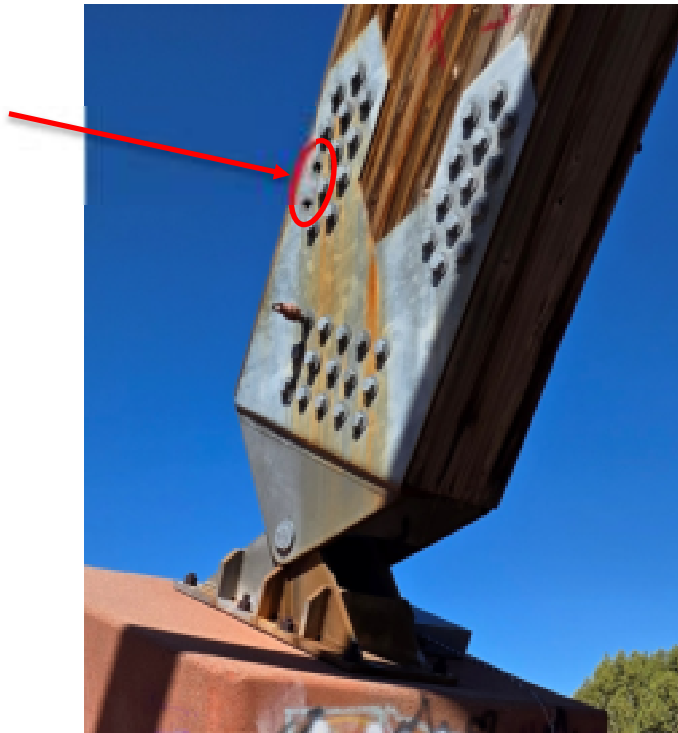
*Figure 2D: View of missing bolts in base connection*

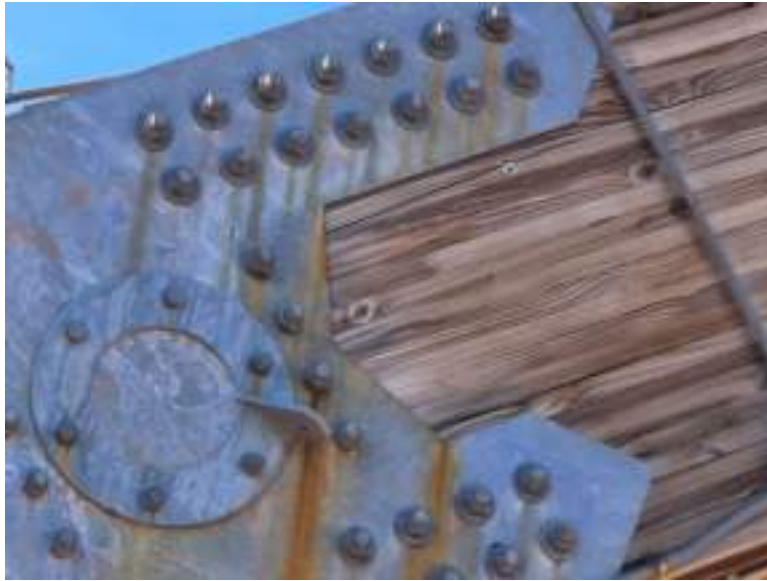
The bolted splices at mid-span appear to be in good condition (Figure 2E). In addition, the bolted hinged connections at the arch apex appear to be in good condition (Figure 2F).

*Figure 2E: View of bolted splice connection*

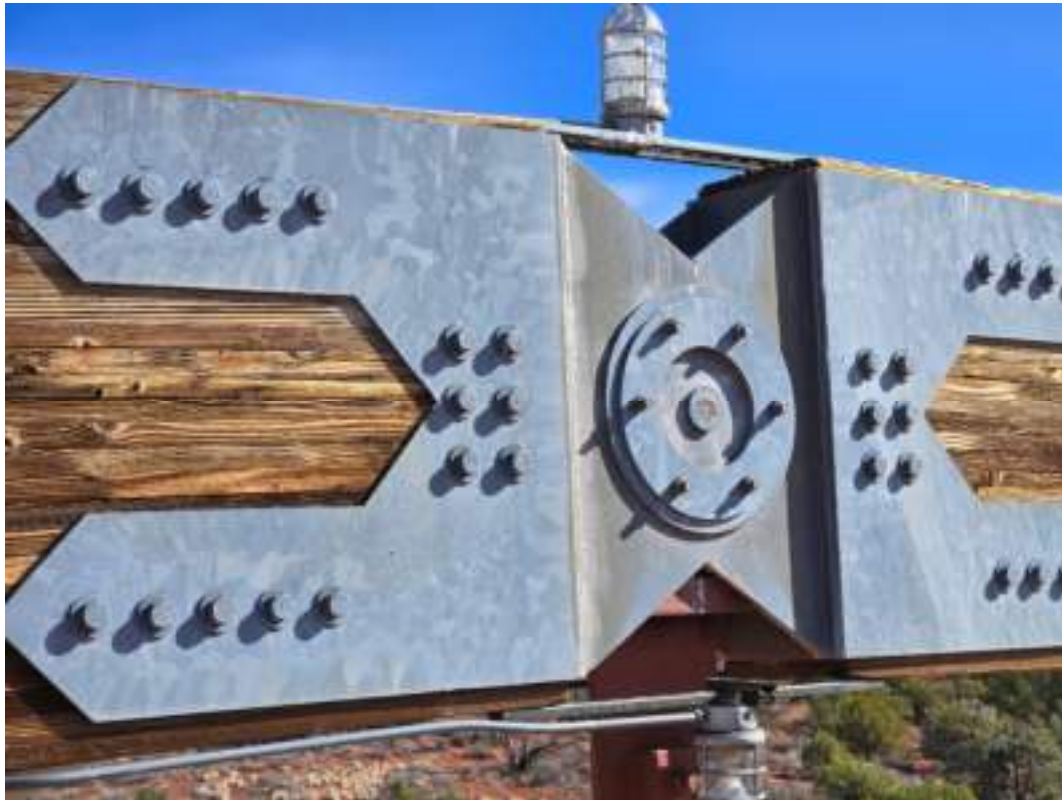
*Figure 2F: View of bolted hinged connection*

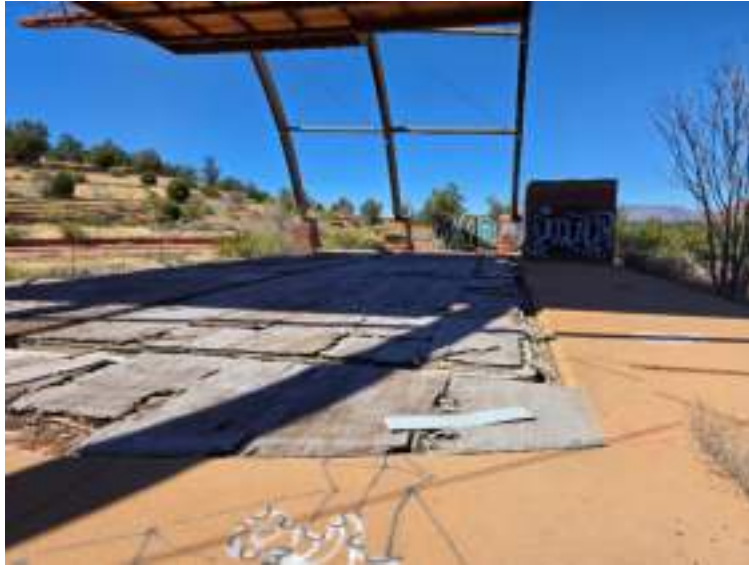
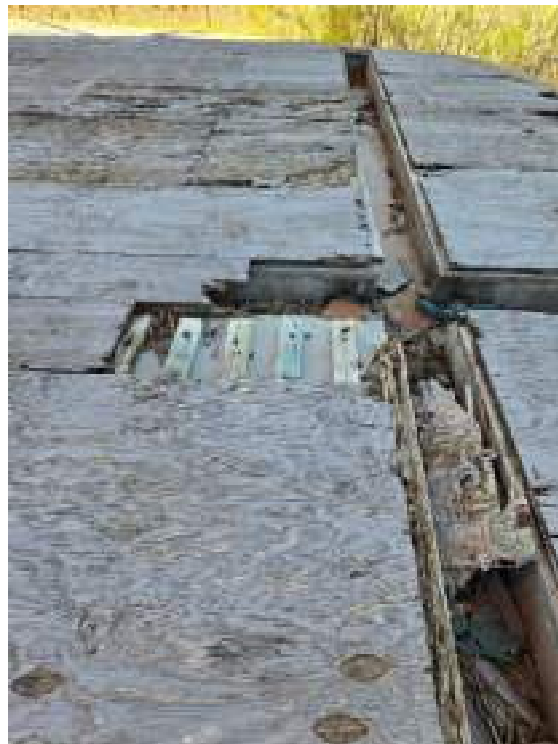
The stage is a cast concrete structure with a wood subfloor consisting of 1-1/8" plywood over 2x wood sleepers over concrete slab on grade. The wood subfloor is severely deteriorated (Figures 2G and 2H).

*Figure 2G: View of deterioration of stage subfloor*

*Figure 2H: View of deterioration of stage subfloor*

Structural Issue #1: The American Wood Protection Association (AWPA) Use Category (UC) system specifies UC3B for "Exposed to all weather cycles including prolonged wetting". The wood members used as the subfloor for the stage do not appear to have any treatment meeting the recommendations of this standard. This and lack of maintenance led to complete deterioration of the wood subfloor.

The wood subfloor of the stage requires complete removal and replacement. It is not possible to remediate the existing deteriorated plywood.

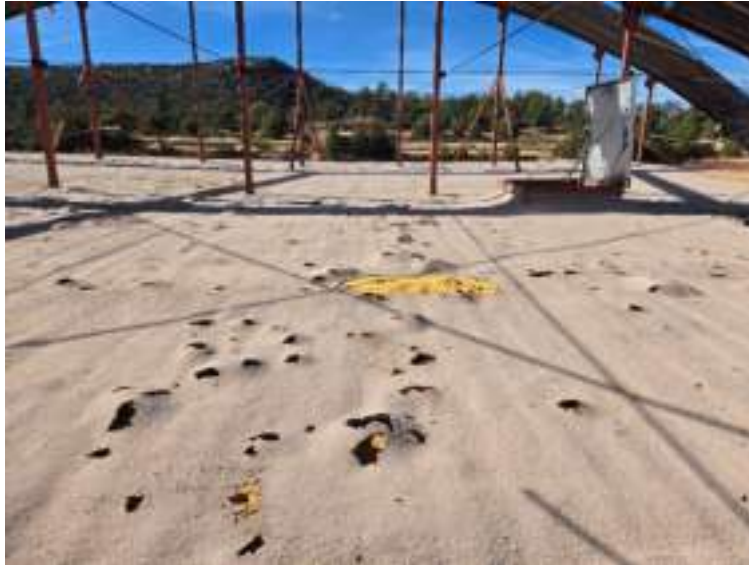
The roof of the canopy is a spray foam over wood decking. The waterproof membrane of the roof has failed in many areas which has led to rotting of the wood decking in some areas (Figures 2I and 2J).

*Figure 2I: View of deterioration of membrane roof*

Structural Issue #3: The failure of the spray foam roofing has led to deterioration of the wood decking.

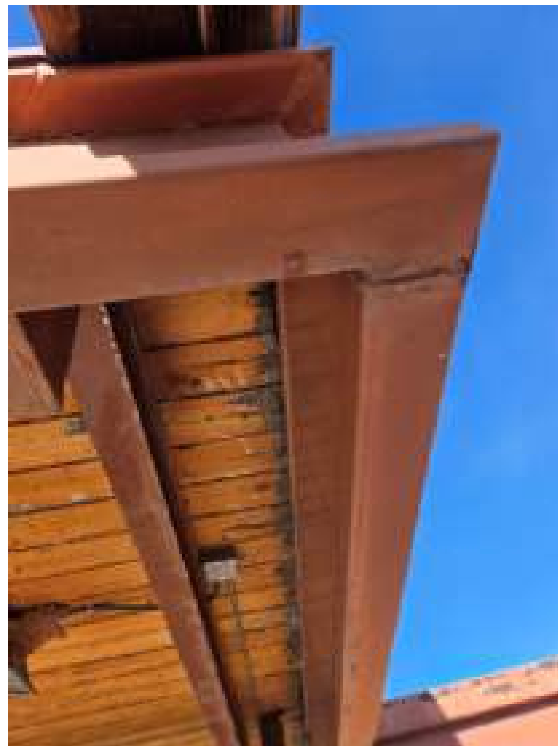
*Figure 2J: View of rotting of wood decking*
